STRESS CORROSION CRACKING FAILURE OF INLAND 303 STAINLESS STEEL ANCHOR BOLT: BOLT AND ROCK CHARACTERISTICS INFLUENCE

Abstract - A serious climbing accident in the Brazilian city of Itatim - BA was caused by the rupture of four anchor bolts after the athlete stopped at an anchor point to rest. Bolt fracture characteristics suggest failure by stress corrosion cracking (SCC), however the great distance from major sources of aggressive agents and the low age of the anchor bolt are concerning. The objective of the work is to evaluate the failure causes focusing specifically on rock and bolt characteristics. Laboratorial results indicate typical composition of a 303 SS, rich in MnS, high levels of residual stress from manufacture and relevant concentrations of Chloride along the bolt cracks. Rock analysis shows no aggressive component in its composition. The investigation concluded that high ion concentrated water inside the hole, along with low corrosion resistance of the bolt material, 303 SS, and manufacturing residual stress were the main factors that contributed for the SCC failure. No evidence that supports the influence of the rock characteristics was found.

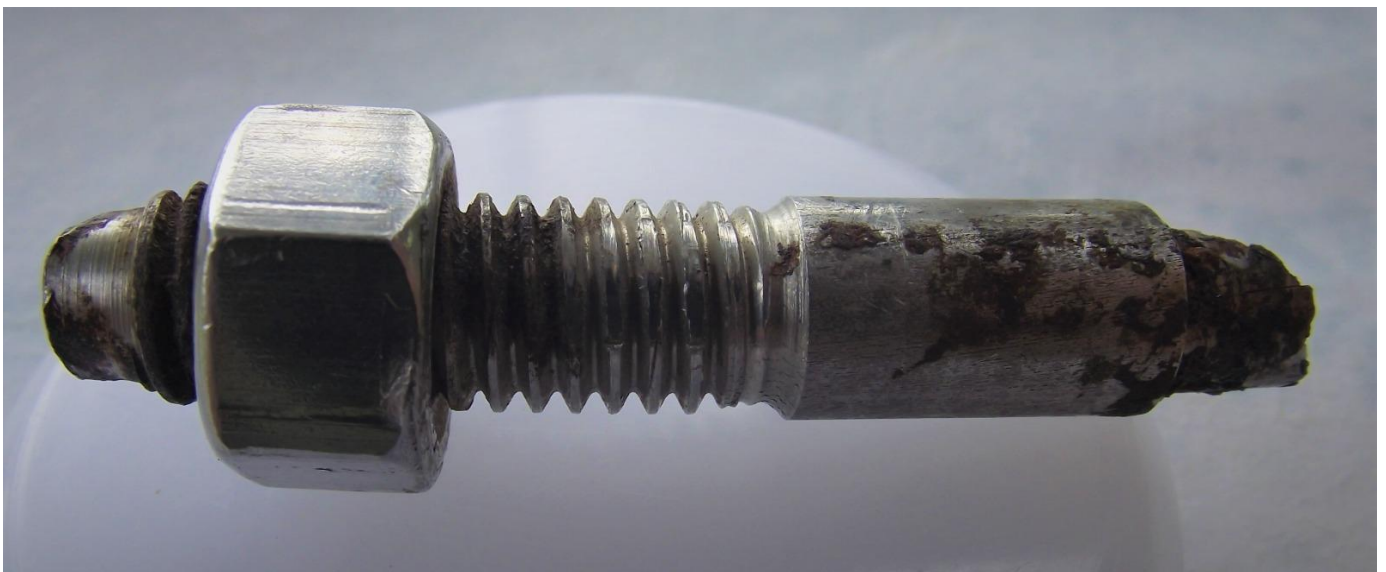
region showed the same kind of failure. The bolts were oxidized, and a brittle fracture was observed in the most corroded region.

Figure 1 - Failed anchor bolt analyzed, Sample

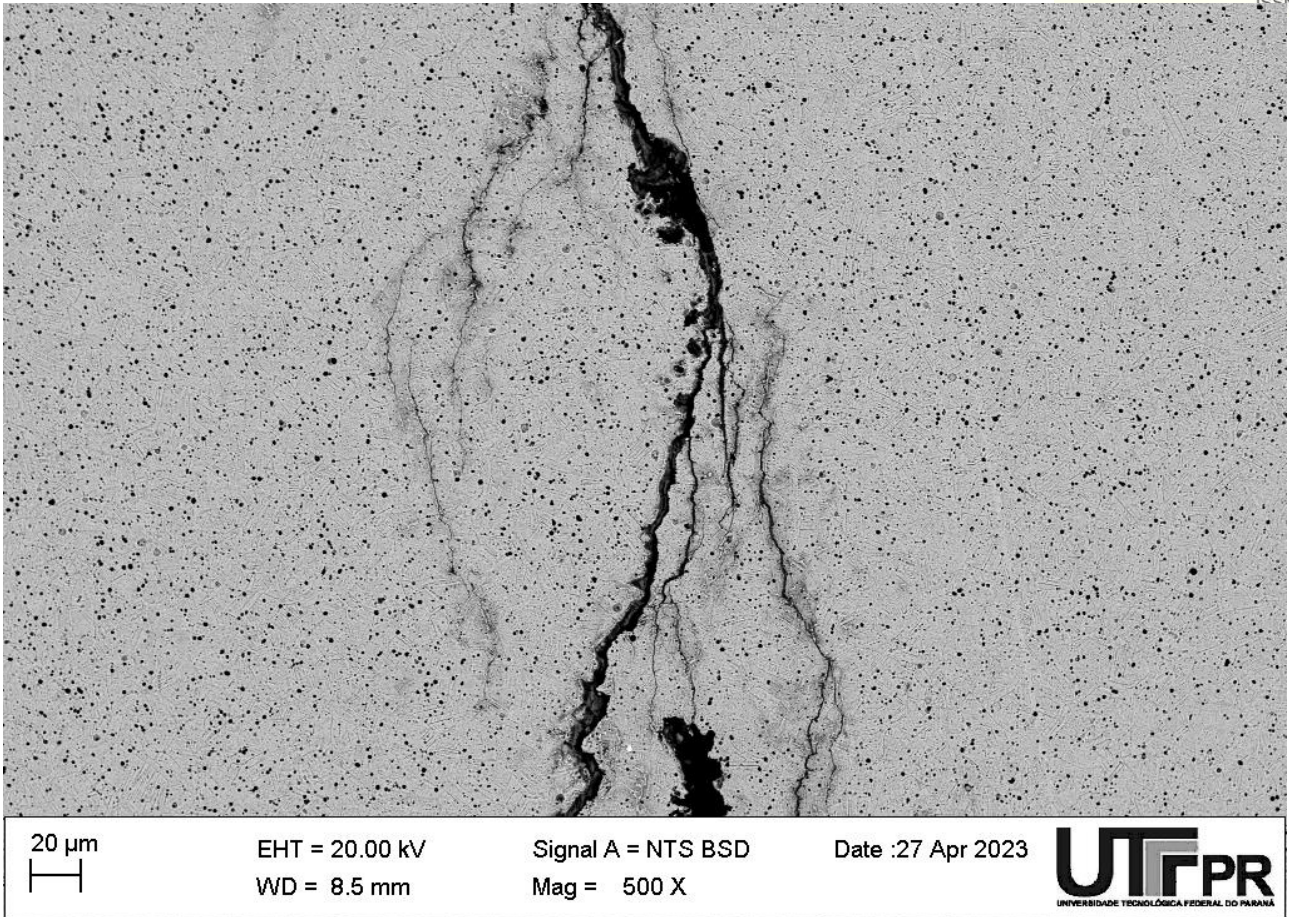
Figure 2 - Main crack on the section and derivations, Sample A, failed bolt, SEM.

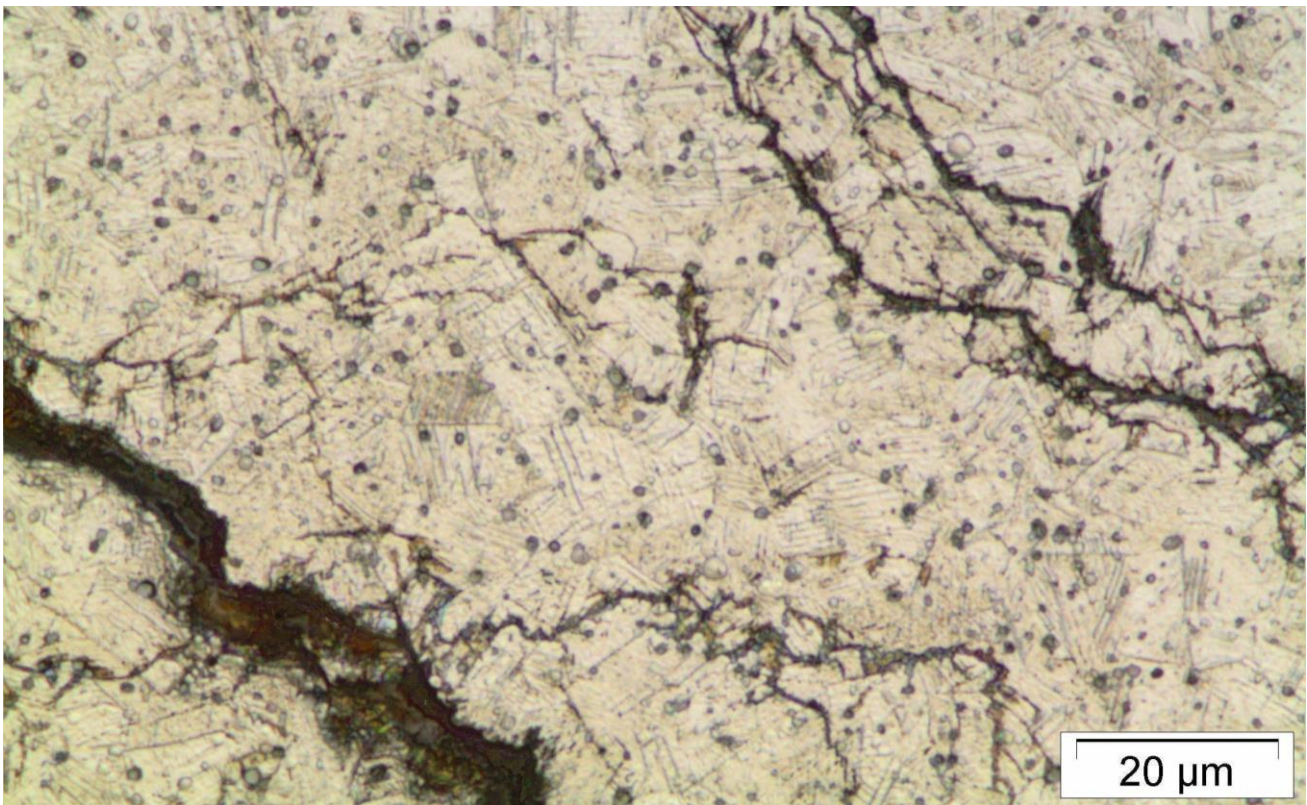
Figure 3 displays the propagation of primary and secondary cracks in sample A via optical microscopy, with clear signs of corrosion. Figures 3 and 4 indicate oxidation preference by twinned regions and clusters of precipitates, with inter and intra granular propagation in both Sample A and the bolt of Sample B, respectively. Cracks were found via SEM in the nut of sample B.

Figure 3 - Main crack on the section and derivations, Sample A, failed bolt, transversal section, Optical Microscope

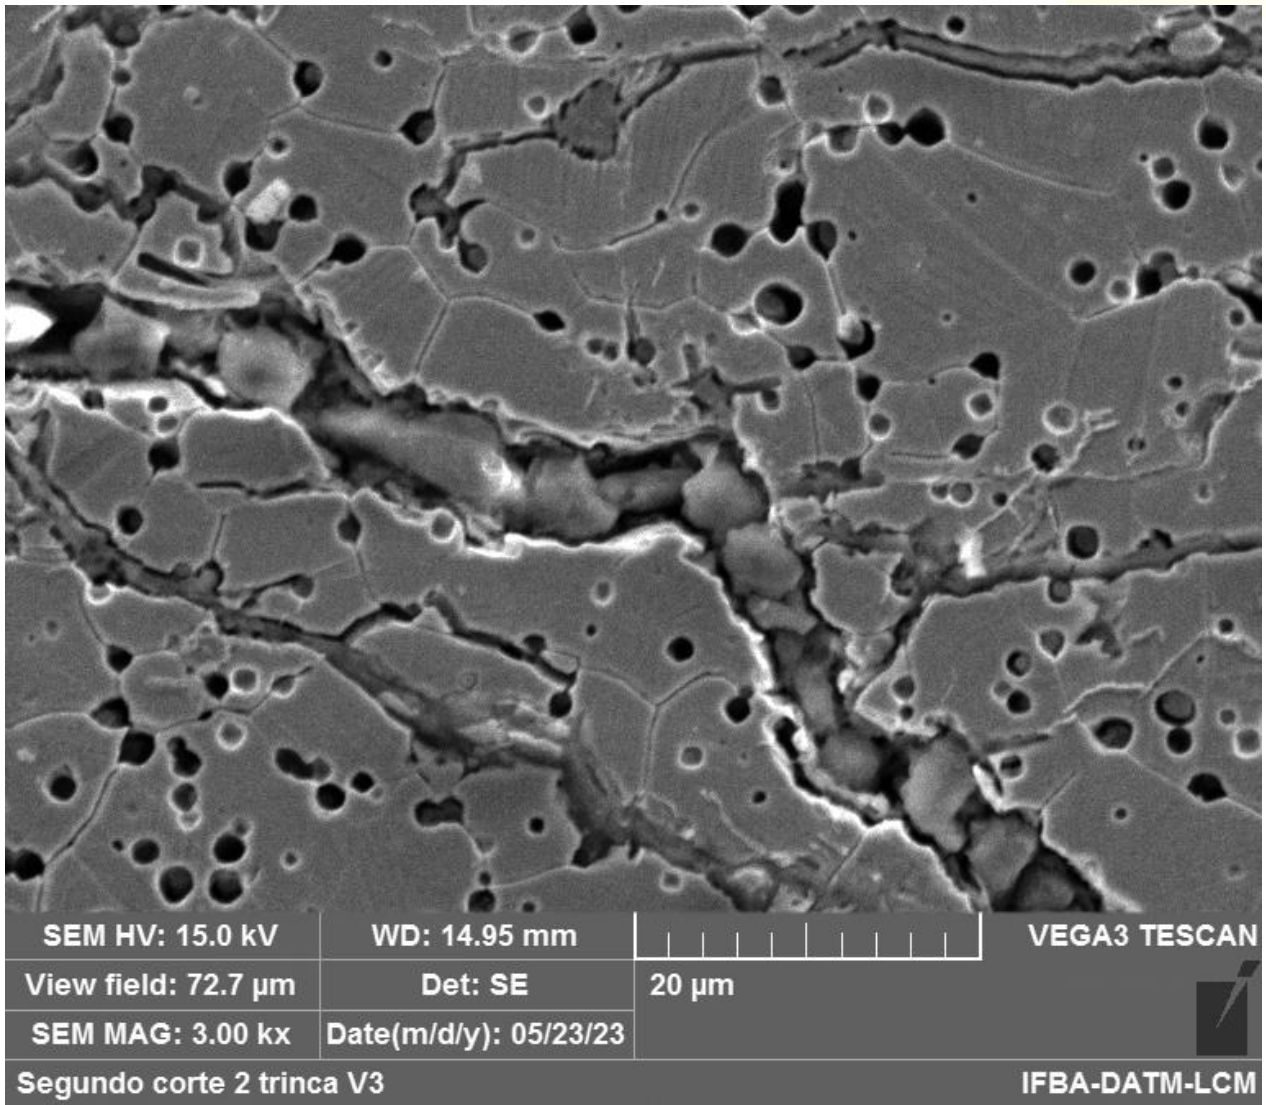
Figure 4 - Propagation of main and secondary cracks, failed bolt, Sample B, transversal section, SEM.

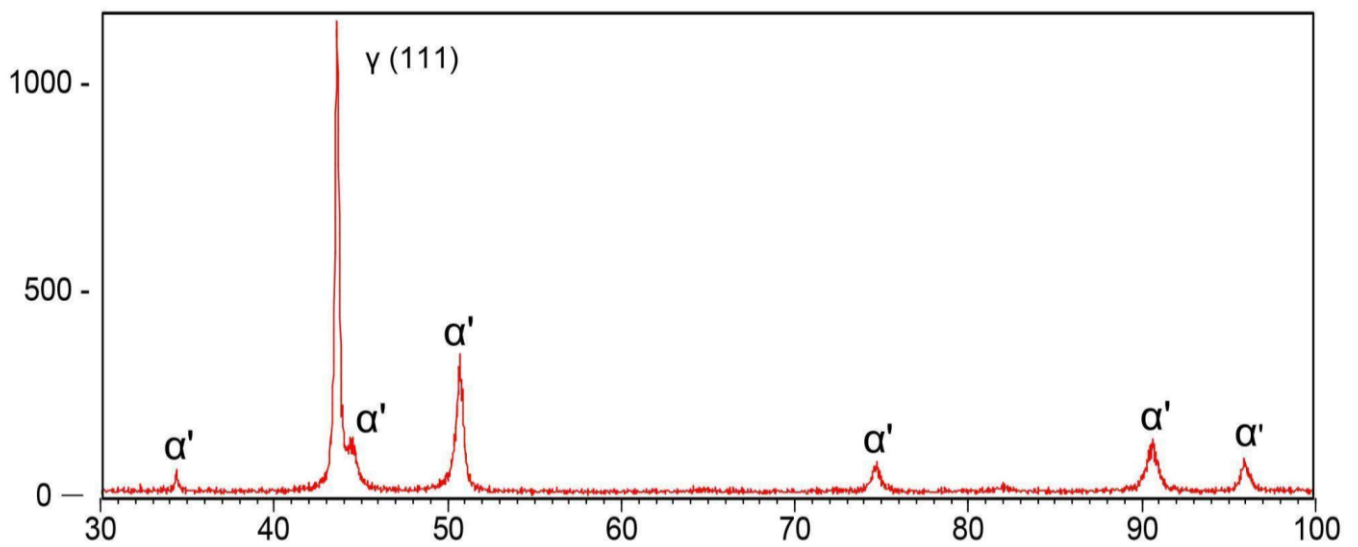
Twins can be seen in both SEM and Optical microscopy images. Martensite presence was confirmed in Sample B via XRD. Martensite appears in Figure 5 as α' peaks, while Austenite in γ peaks.

Figure 5 - XRD results shows Austenite presence (γ) and martensite (α').

2. The residual stress in the fractured anchor bolt is demonstrated by the elevated hardness and martensite presence, the result of high deformation during the manufacturing process without proper subsequent heat treatment being carried out. These stresses were sufficient for crack propagation, especially in conjunction with MnS.

3. After the cold work, some kind of stress relief and solubilization is recommended. For stainless steel alloys containing carbon, stress relief in higher temperatures with cooling by quenching prevents chromium carbide precipitation in temperature ranging from 425°C to 900 °C and maintains a moderate SCC resistance. For low carbon alloys, most high temperature stress reliefs are suitable for moderate SCC resistance. British stainless-steel association (2024) shows these and other recommendation for stress relieving in stainless steel.

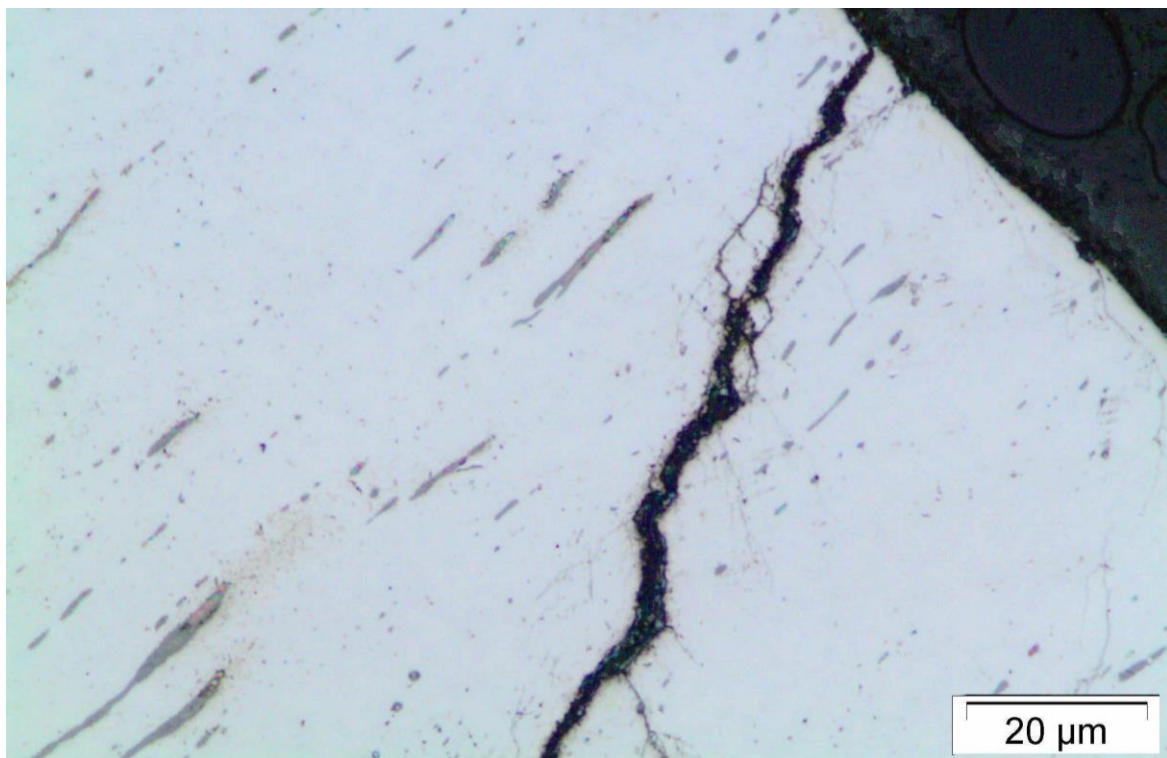
In the longitudinal section these precipitates present an elongated configuration, and it can be seen in Figure 6 that they are crack initiation

points, although cracks don't follow them in the longitudinal direction.

Figure 6 - Propagation of a crack and MnS precipitates in the longitudinal section of sample A, longitudinal section, SEM.

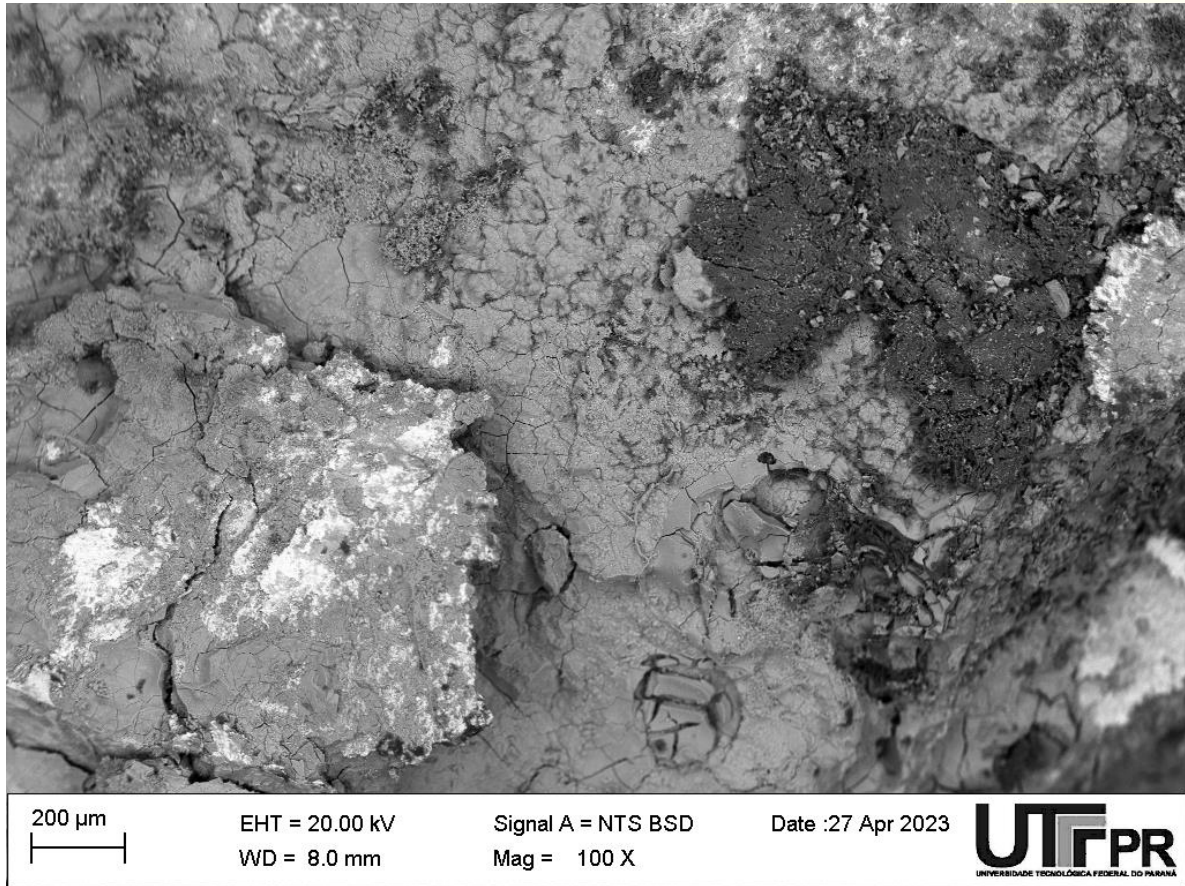
SEM images of the fracture in Sample A are displayed in Figures 7 and 8. The images magnified at 500x reveal the various micro cracks, evincing great embrittlement.

Section cracks composition varies considerably from those of the Matrix and Precipitates. Sodium (Na) and Chlorine (Cl) appear in the form of oxides, as well as small values of Sulfur (S) and Potassium (K). In the fracture surface, oxide presence is much larger in comparison with other regions, with Sodium (Na) and Chlorine (Cl) as the main components, and Potassium (K) in similar amount as found in the cracks.

Figure 7 - Fracture image, darker regions show oxide crystals formation, SEM.

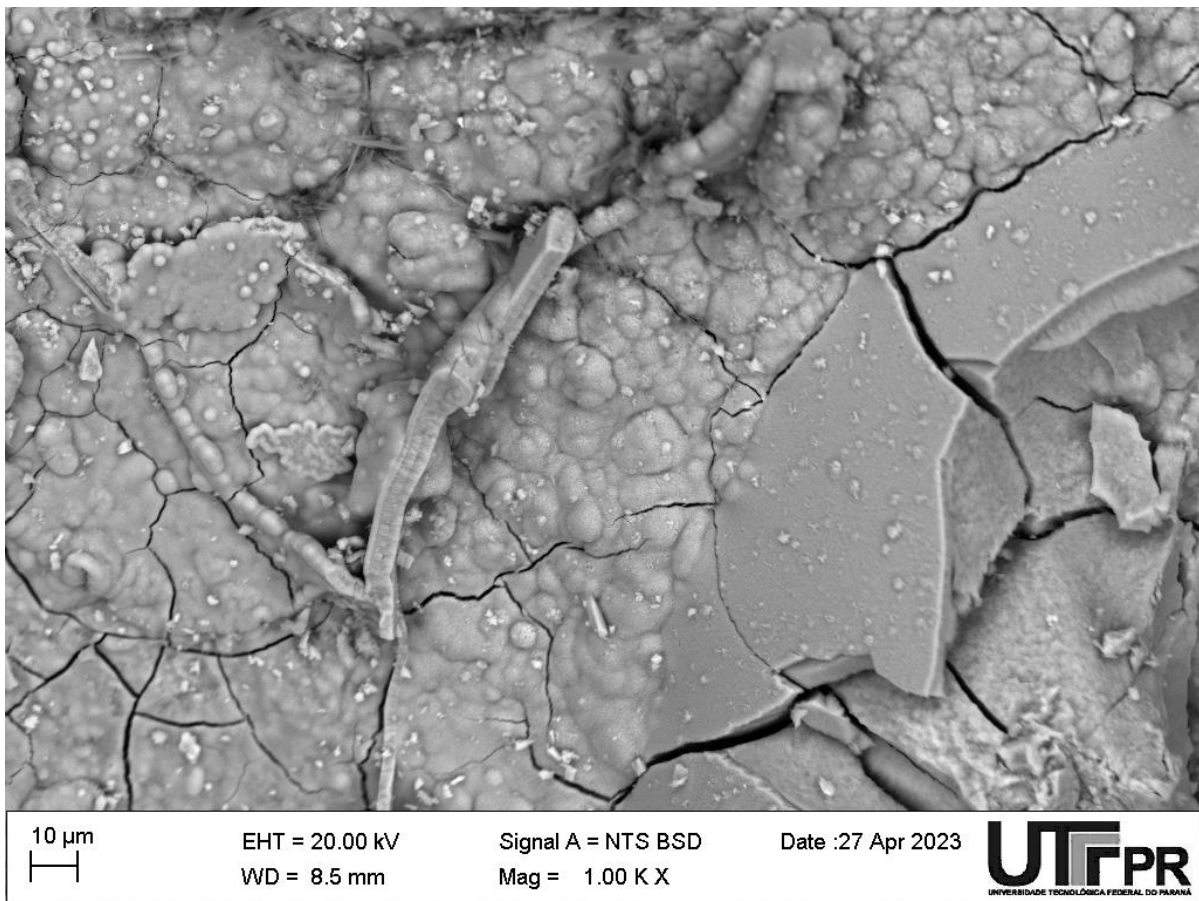
Figure 8 - Cracks on the fractured surface, including a fractured MnS, SEM.

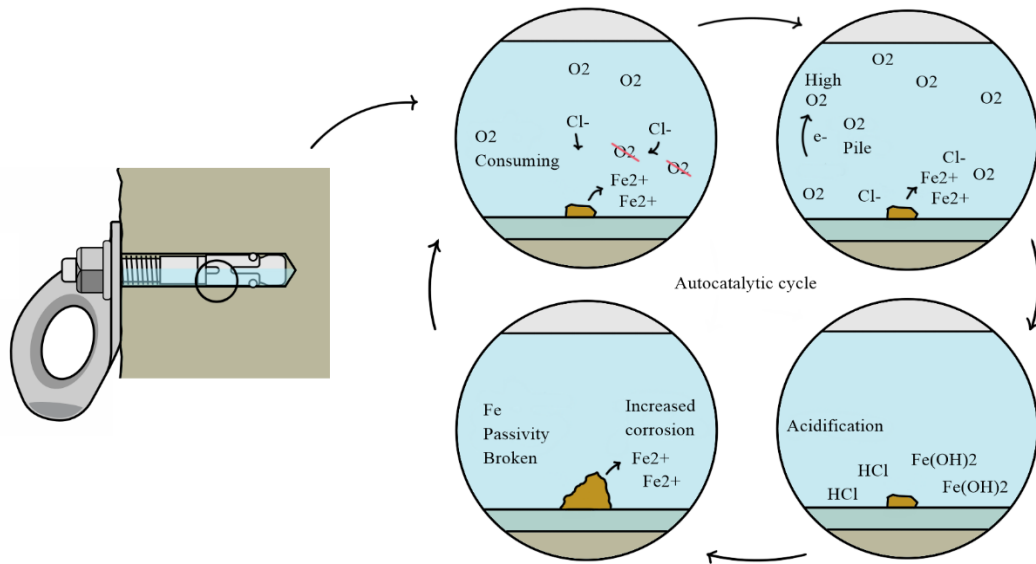
the main mechanism of corrosion in a bolt inside a hole is crevice corrosion, in which oxygen concentration difference between the surface of the liquid and its bottom causes a pile that increases its strength through time by acidification, that facilitates electronic changes, and by oxygen consumption, that raises the

difference in oxygenation and build up corrosion potential. Rain washing can mitigate this process by renewing water inside the hole, maintaining pH closer to neutral and oxygen differences constant. Figure 9 provides a visual representation of the process.

Figure 9 - Illustration of crevice corrosion mechanism in an anchor bolt hole. Source: Authors own elaboration.

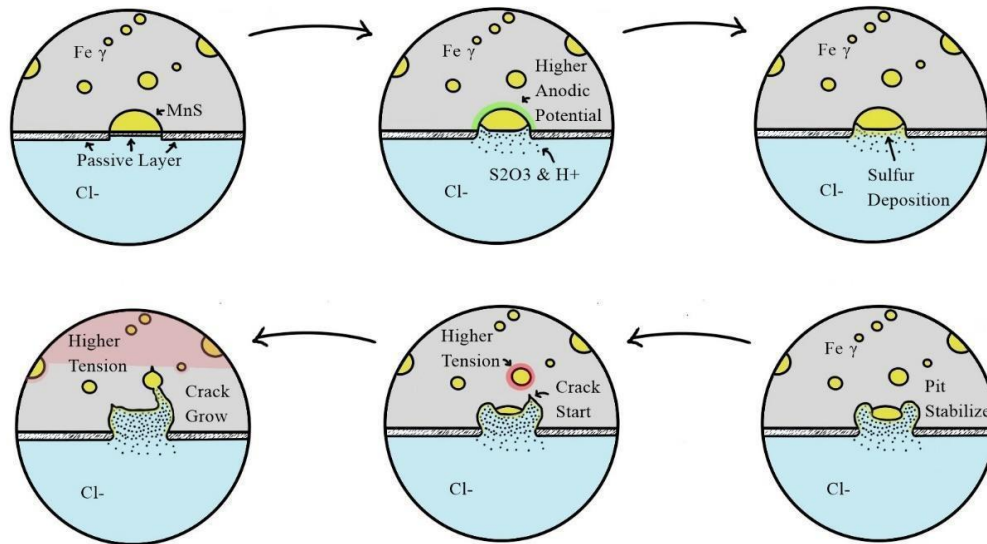
Considering the composition of the matrix and the high concentration of Manganese (Mn) and Sulfur (S) rich precipitates, the material was identified as AISI 303 SS, in which Sulfur (S) is added in steel manufacture to form Manganese Sulfide (MnS)., (International Organization for Standardization, 2014). Copper (Cu) was also found in high concentrations near the precipitates, and its affinity with MnS is known (Lillard, Ka, Marjan & Niu, Wei, 2016). Microstructure appearance in the longitudinal section is typical of rolled AISI 303 SS, (Newby, Mills & Asm Handbook Committee, 1985). MnS is known for contributing to corrosion because: it destabilizes the passive layer, serving as an initiation point of oxidation, as the weaker passive layers breaks and water makes contact with the Iron (Fe) matrix (Duan, Man, Cui, Hong-Zhi, et al, 2022; Muto, Izumiyama, & Hara, 2007); the region around it has a higher anodic potential, that is translated in a lower oxidation resistance area and a preferential corrosion path (Suter & Bohni, 2001; Vuillemin, Philippe, et al, 2003); its dissolution produces H⁺, which makes the medium more aggressive, especially around the MnS inclusions (Alnajjar, Christien, Barnier, Bosch, Wolski, Fortes & Telling, 2020); finally, it serves as tension concentrator points, for crack propagation, leading the corrosion through specially prone areas (Gu, Lian, Bao, Xiao, & Muenstermann, 2019). Figure 10 offers a visual

schema of how MnS promotes corrosion and crack propagation.

Figure 10 - Illustration of SCC facilitated by Mn. Source: Authors own elaboration

4. For structural applications, especially in the case of personal safety equipment, sulphurated, non-stabilized and standard carbon stainless steel should be avoided. This work shows the impact of MnS in SCC resistance in 304 SS, while stabilized and low carbon alloys are known for its superior corrosion and sensitization resistance.
